# Vittoria Old Town Hall (F638)

1538 Old Brock Street, Vittoria (ON)

The Corporation of Norfolk County  
Revised Final Report  
Building Component Inventory &  
Building Condition Assessment

June 14, 2023

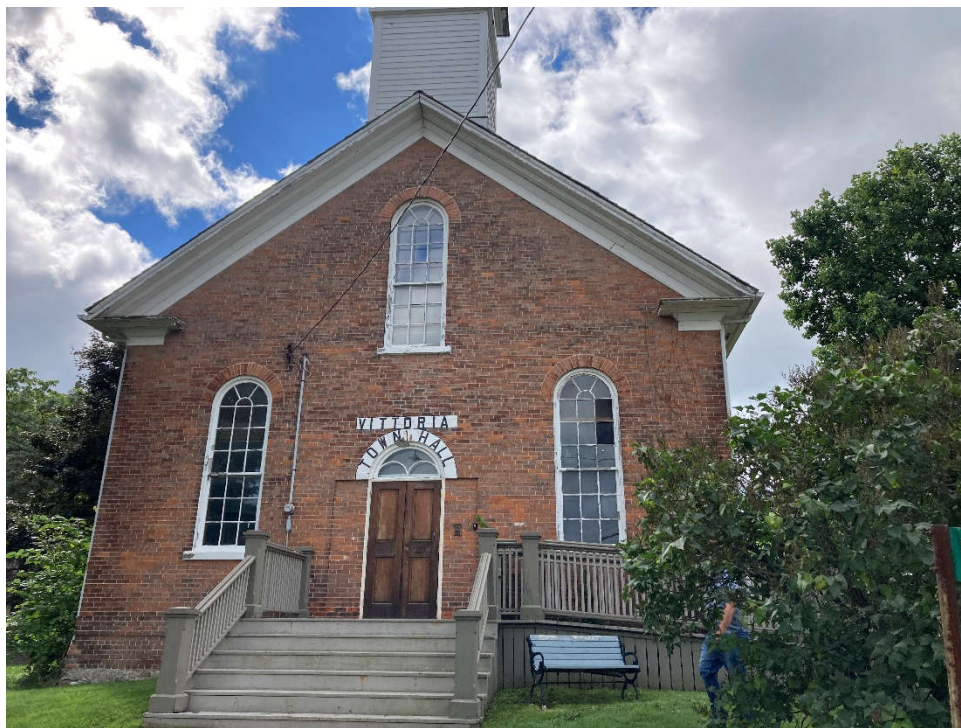
Photo 1: General view of the building
