Norfolk County – Operation Division - Facilities Department  
50 Colborne Street South  
Simcoe, ON  
N3Y 4H3

Project No. 22118

**Re: Norfolk County Facilities Restoration  
Site Visit Observations and Assessment**

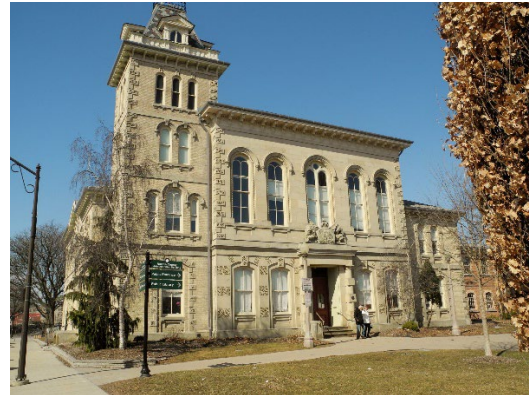
Figure 5: Exterior view of the County Administration Building

The building has three accessible main levels in the primary structure: two upper levels and one basement level. A five-story tower joins the main building. A second wing adjoins the building with two upper levels and one basement level—an intermediate wing connecting the building, linking it to the adjoining Library. The exterior walls of the building are primarily constructed of yellow brick masonry clad with imported Ohio stone. The building contains a basement level constructed using red-brick masonry, with the same being present on all interior walls of the building.

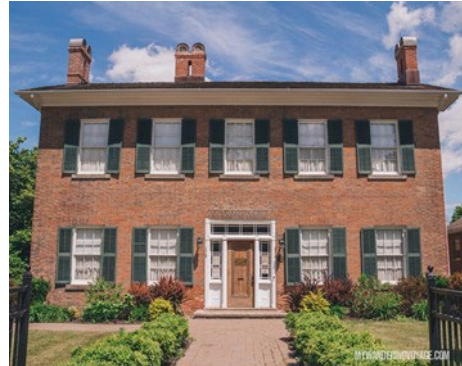
Figure 7: Exterior view of the Norfolk County Archives

The structure, the primary focus of this scope, is two stories, plus an attic and partial basement. A crawl space is under the remainder of the home. The building is multi-wythe brick masonry, on a composite stone and brick foundation. The home is currently used for exhibit space reflecting the home in its historical context and exhibit space for museum functions. The windows are symmetrically aligned throughout the facades, with shutters. The roof has five (5) chimneys, each with similar detailing. While the home has been a museum, several modifications have been completed. Notably, an addition at the rear, used for archival, museum, storage, and display purposes. In 2014, the main entryway, was rehabilitated, along with the façade masonry and chimneys.

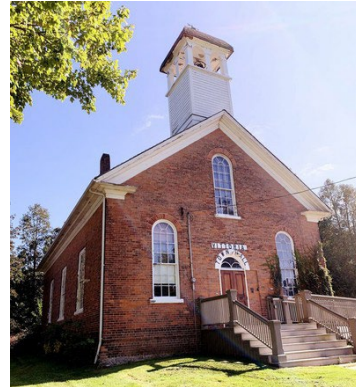
Figure 3: Exterior view of the Vittoria Old Town Hall

The historic structure, which is the focus of this scope of work, is one central story; within the main space, the building is the height of two stories. The building is multi-wythe brick masonry on a mass-masonry fieldstone foundation. Above the front entrance is a timber cupola/bell tower containing the bell. The roof features three (3) chimneys, each with similar detailing. On the interior, at the entrance to the building, is a single-story space of a lower ceiling height, above which a second level mezzanine/storage area is presently accessible by ladder. The main space of the building is open with a stage at the rear of the building. The central attic is accessed by ladder from the mezzanine, and spans the entire length. The roof structure consists of wood rafters and intermittent diagonal members and ties, plus large timber framing supporting the cupola/bell tower that bears on the east and west brick walls to either side. A secondary attic extends above the main attic, which enters the interior structure of the cupola/bell tower. Below the building is a crawl space accessible only by a small hatch through the stone masonry providing access to the joist and flooring composition of the structure.
